## DEPARTMENT OF THE ARMY

SUBJECT: Civil Action 80-73699 - Consent Decree, BASF Wyandotte Corp.,  
Riverview, Michigan, Site Modification Program

Record of Events Pertaining to  
Non-Compliance of the North Clay Cap Cover  
at the BASF Wyandotte Corp., Riverview Site,  
Riverview, Michigan

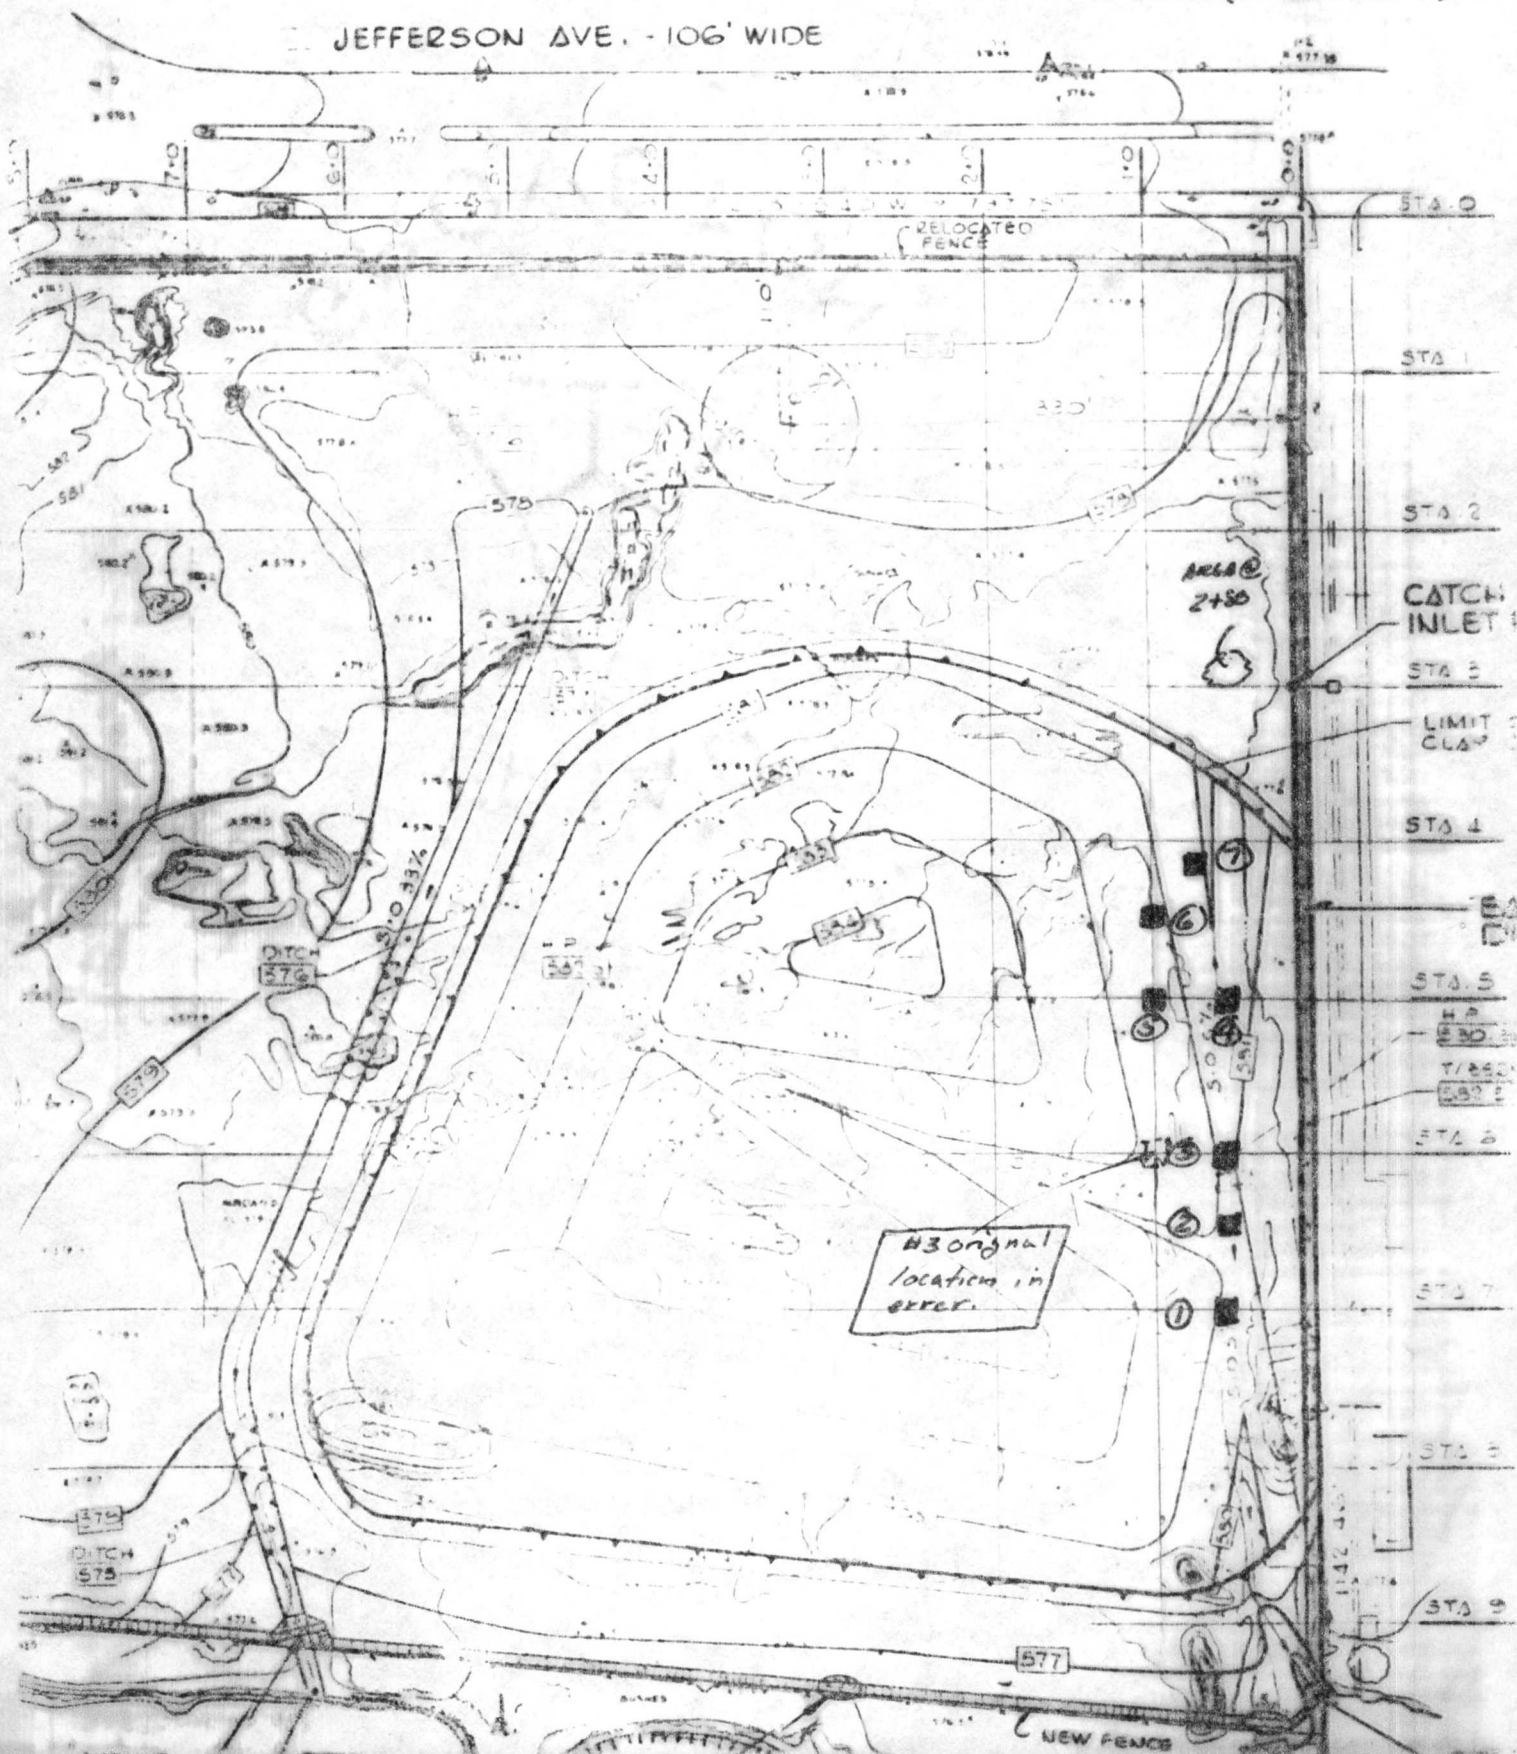
- 1) Soft grey black material was discovered coming up through the brown compacted clay cover material.
- 2) Seven problem areas were identified and approximate locations recorded in daily Inspection Report No. 51 (sketch attached).
- 3) Mr. Jameson manually probed the problem areas and determined that the clay cover thickness in those areas appeared to be less than 24 inches.
- 4) BWC had requested their Contractor, B&V, not to work in the problem areas. However, Contractor did continue to work in the general area.

1. As reported by your surveyors, final grades taken in the area bounded by E-W coordinates 0+0 and 2+0 and N-S coordinates Station 2+0 and Station 7+0 indicate that the 24 inch thickness of clay cap material has been achieved.
2. Observations by COE on-site inspector indicate that the 24 inch minimum thickness of clay cap material required by the Consent Decree has not been obtained in the following areas:

Area	Coordinates	
	E-W (Line)	N-S (Line)
1	0+50+/-	7+00+/-
2	0+50+/-	6+50+/-
3	1+00+/-	6+00+/-
4	0+50+/-	5+00+/-
5	1+00+/-	5+00+/-
6	1+00+/-	4+50+/-
7	0+75+/-	4+20+/-

a) Mr. Woodruff visited the site to observe the excavation of the seven problem areas. Six of the areas proved to have less than the required 24 inches of cover. The seventh was a soft area and was refilled for additional compaction. The six remaining non-compliance areas were treated as follows:

1) Each area was excavated until the perimeter showed a minimum brown clay thickness of 24 inches. Each of the areas turned out to be localized.

2) Approximately 1 foot of dry concrete mix was spread on the bottom of each excavation to act as a soil stabilizer. The additional material excavated to accommodate the dry mix, along with the excavated soft grey black material was placed under two feet of brown clay in the north east corner of the north compacted clay cover area on the south west edge of the north concrete ditch.

3) 24 inches (in two lifts) of acceptable brown clay was placed in each excavation and compacted.
